TRIP REPORT

DATE: May 1, 2014

LOCATION: TERRY JONES PROPERTY, EMMETT IDAHO

TERRY JONES
CONSTRUCTION AND SITE PHOTOS

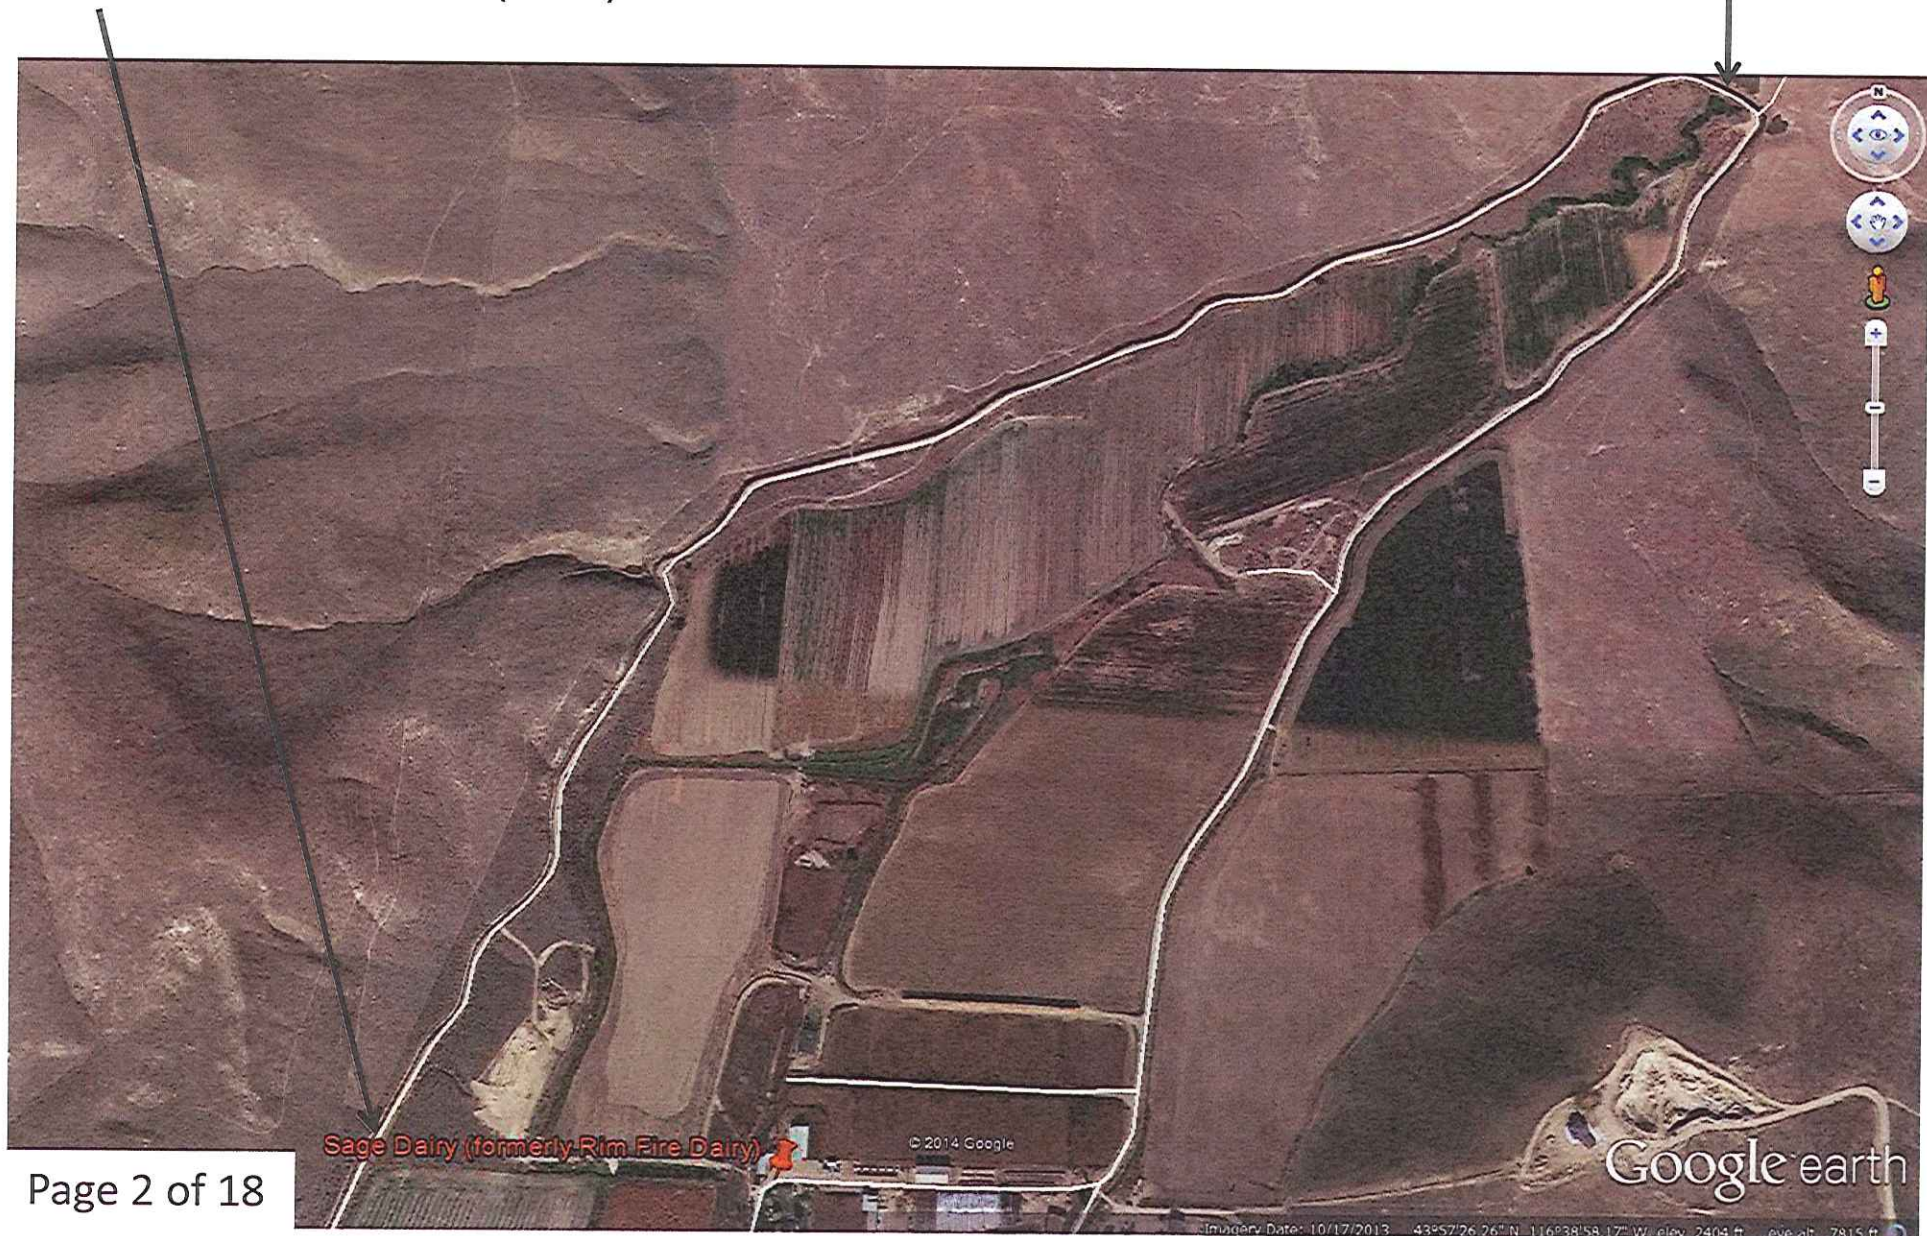
Canal company has blocked old point of diversion with moveable wood wier boards, but has left the structure in place for future emergency situations. (Locations are approximate; for illustration purposes only.)

Old Point of Diversion (2013 and before)

New Point of Diversion (2014)

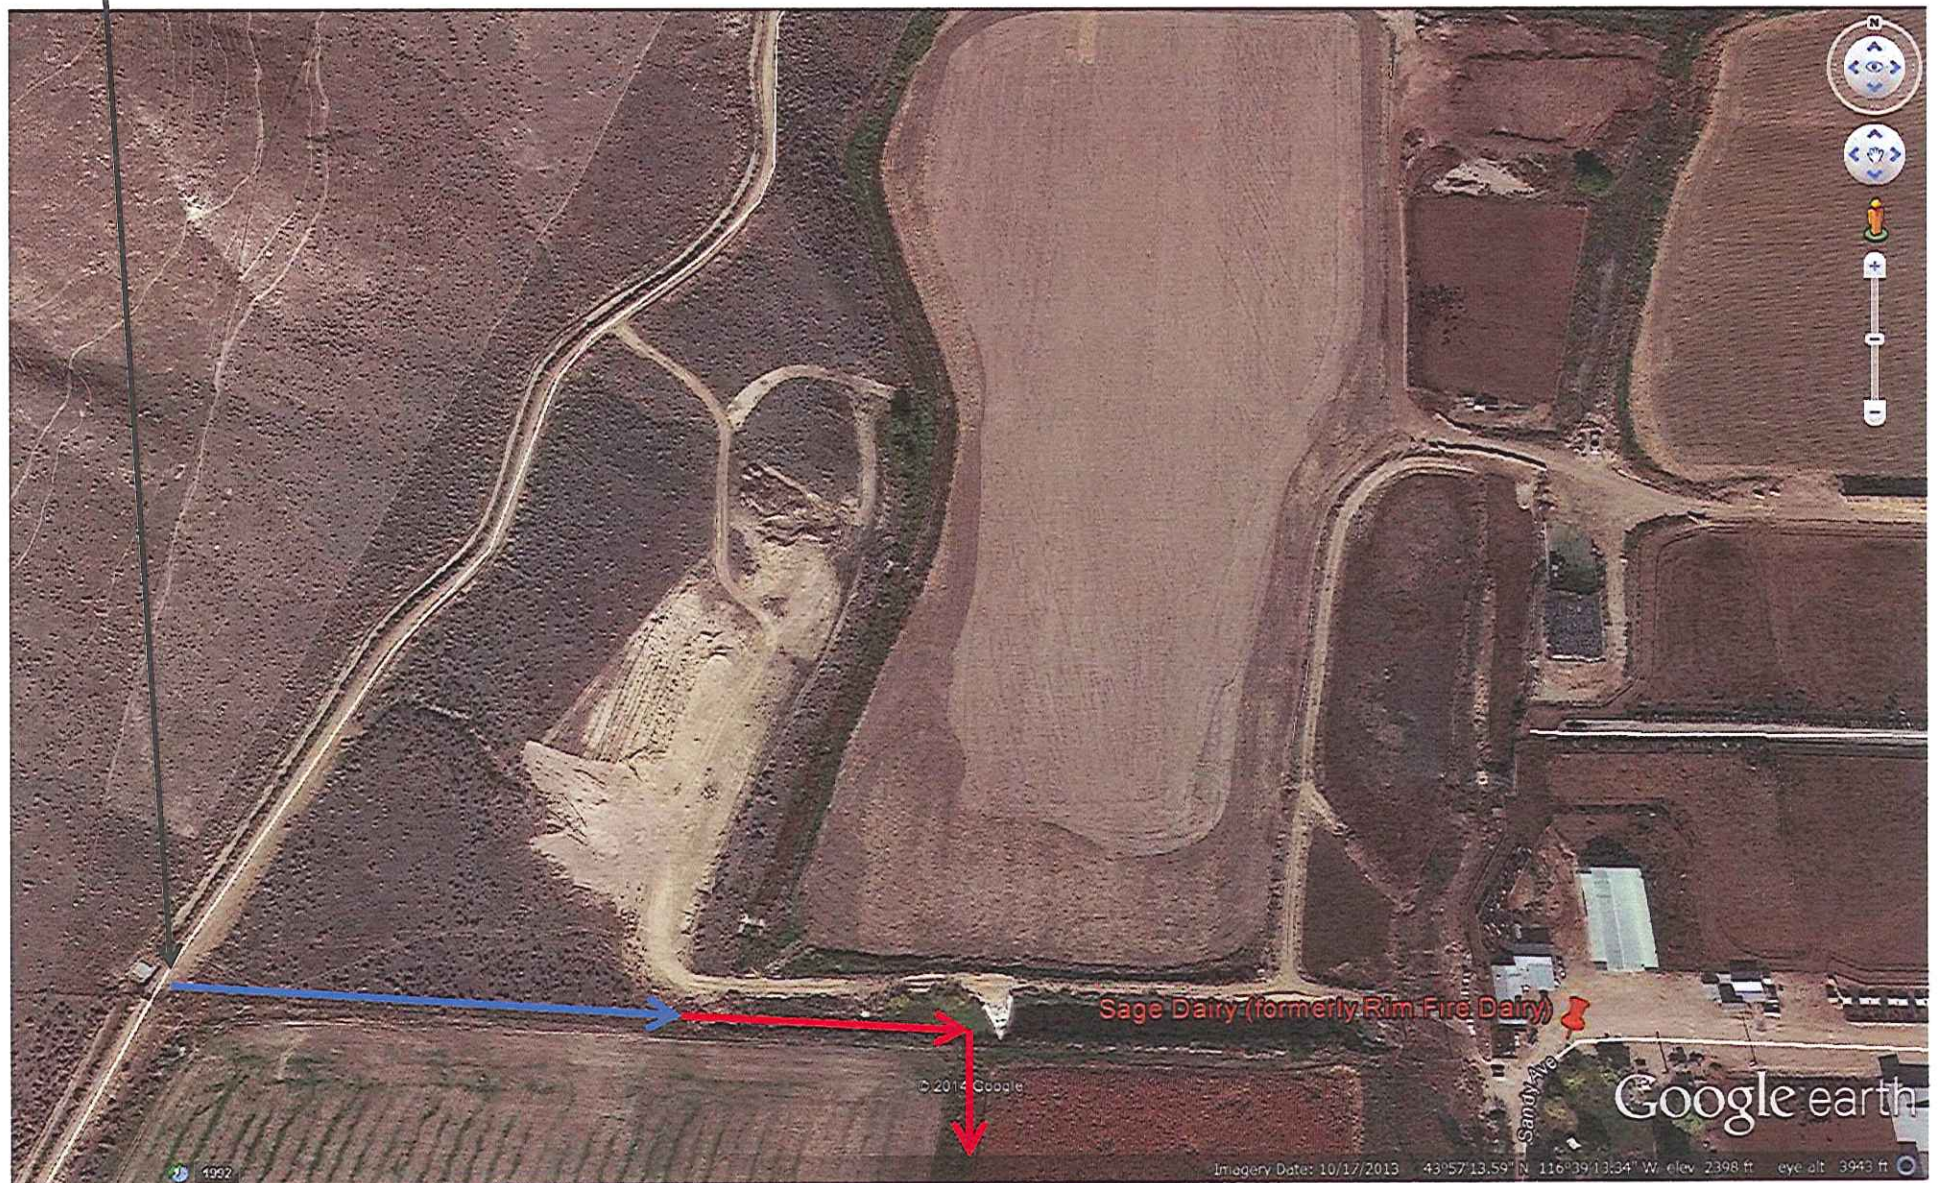
New Point of Diversion (2014); Blue Arrow Indicates water flow direction from the point of diversion and buried pipe for water conveyance. Red line indicates open channel water flow.

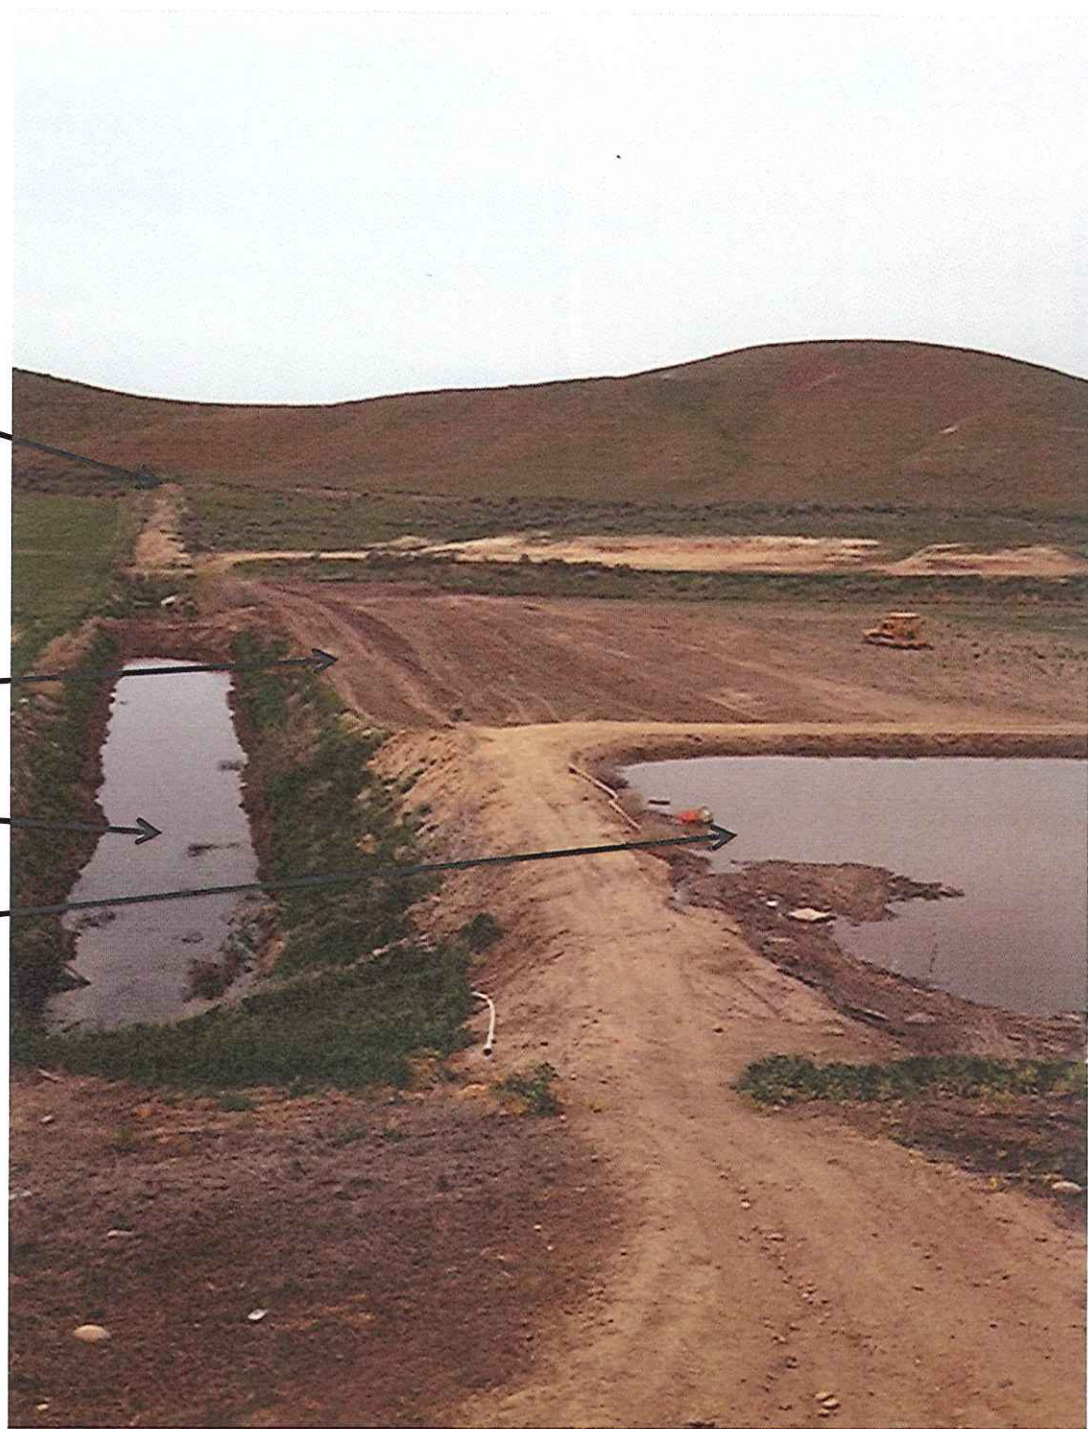
New Point of Diversion (2014)

One can also see where the buried pipe was placed (disturbed earth)

New end of field berm

Tail water pond (3rd party controlled)

Dairy waste pond (Dairy controlled)

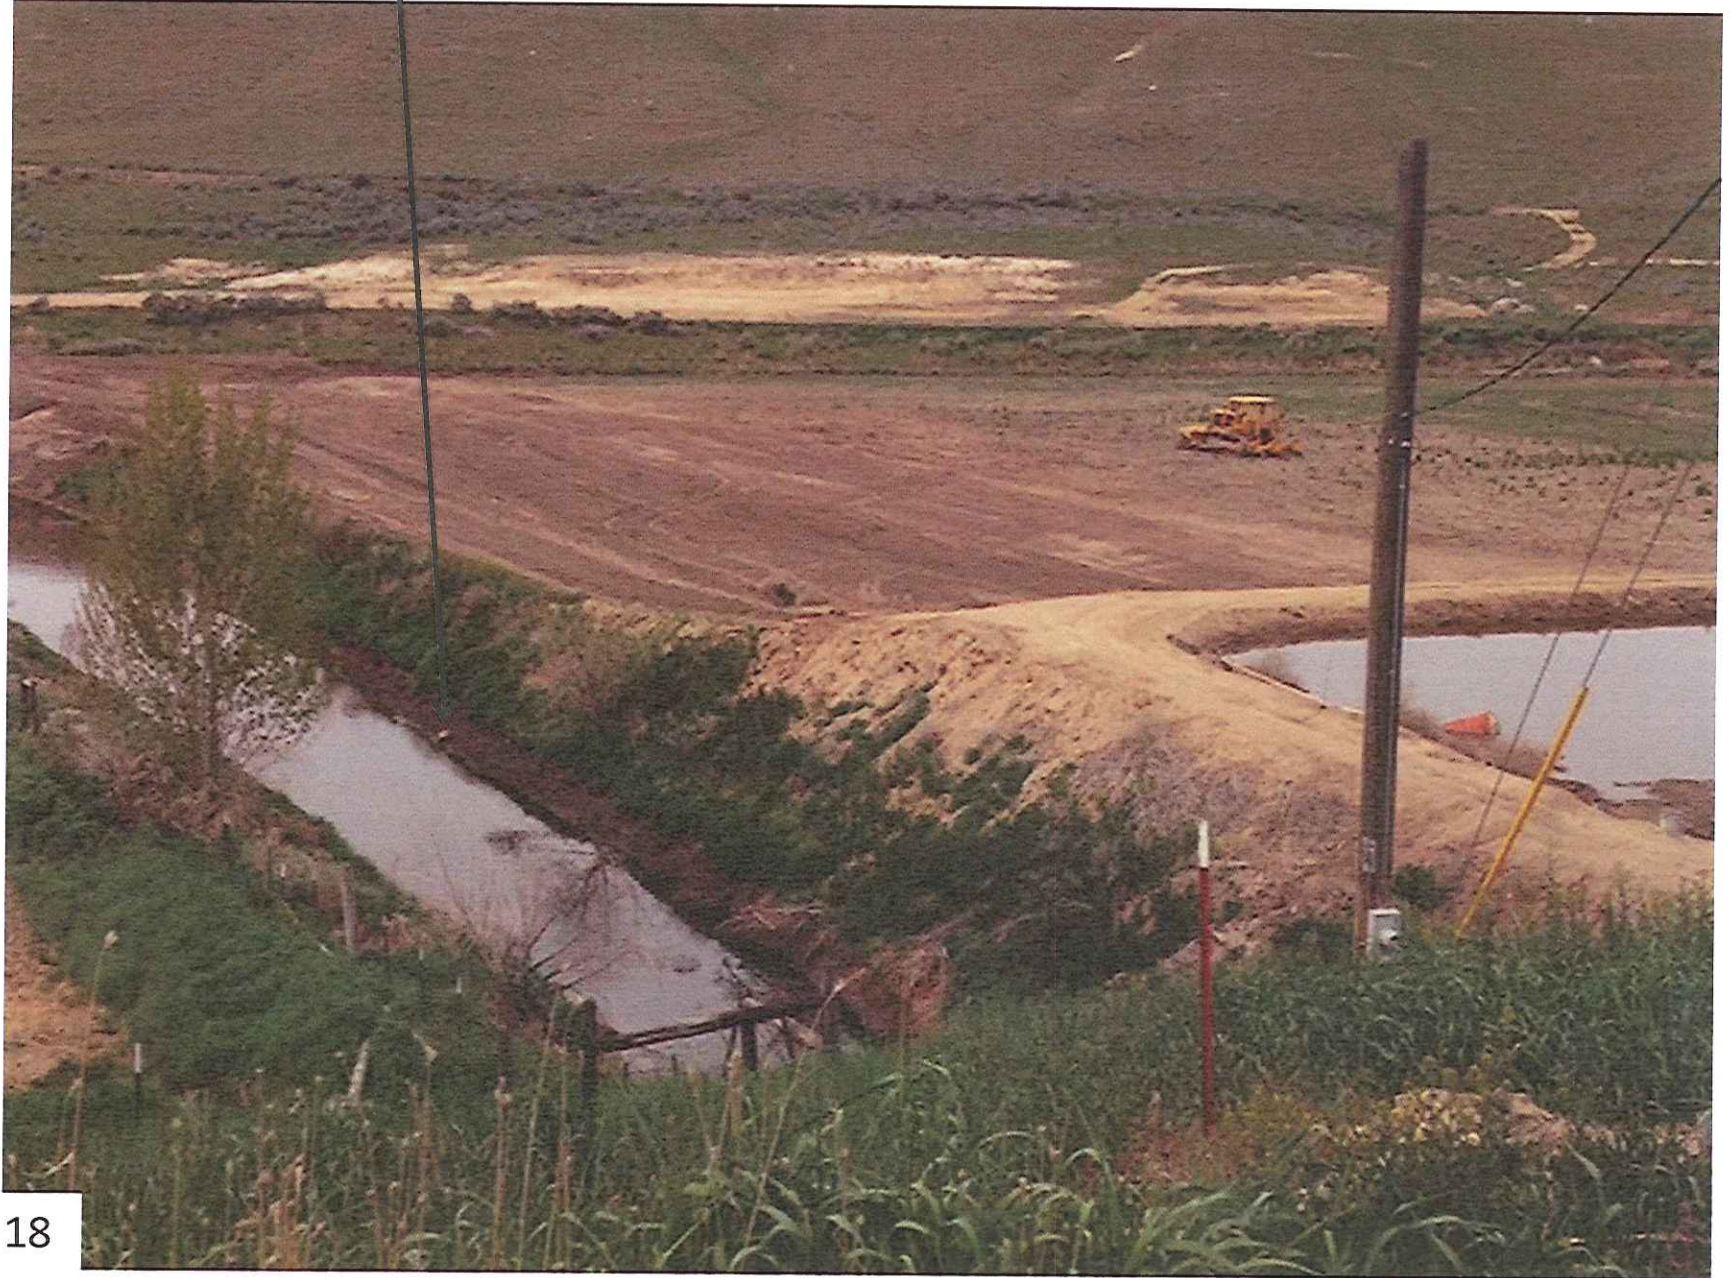
~8 inch Pipe goes through the berm to
collect the field runoff

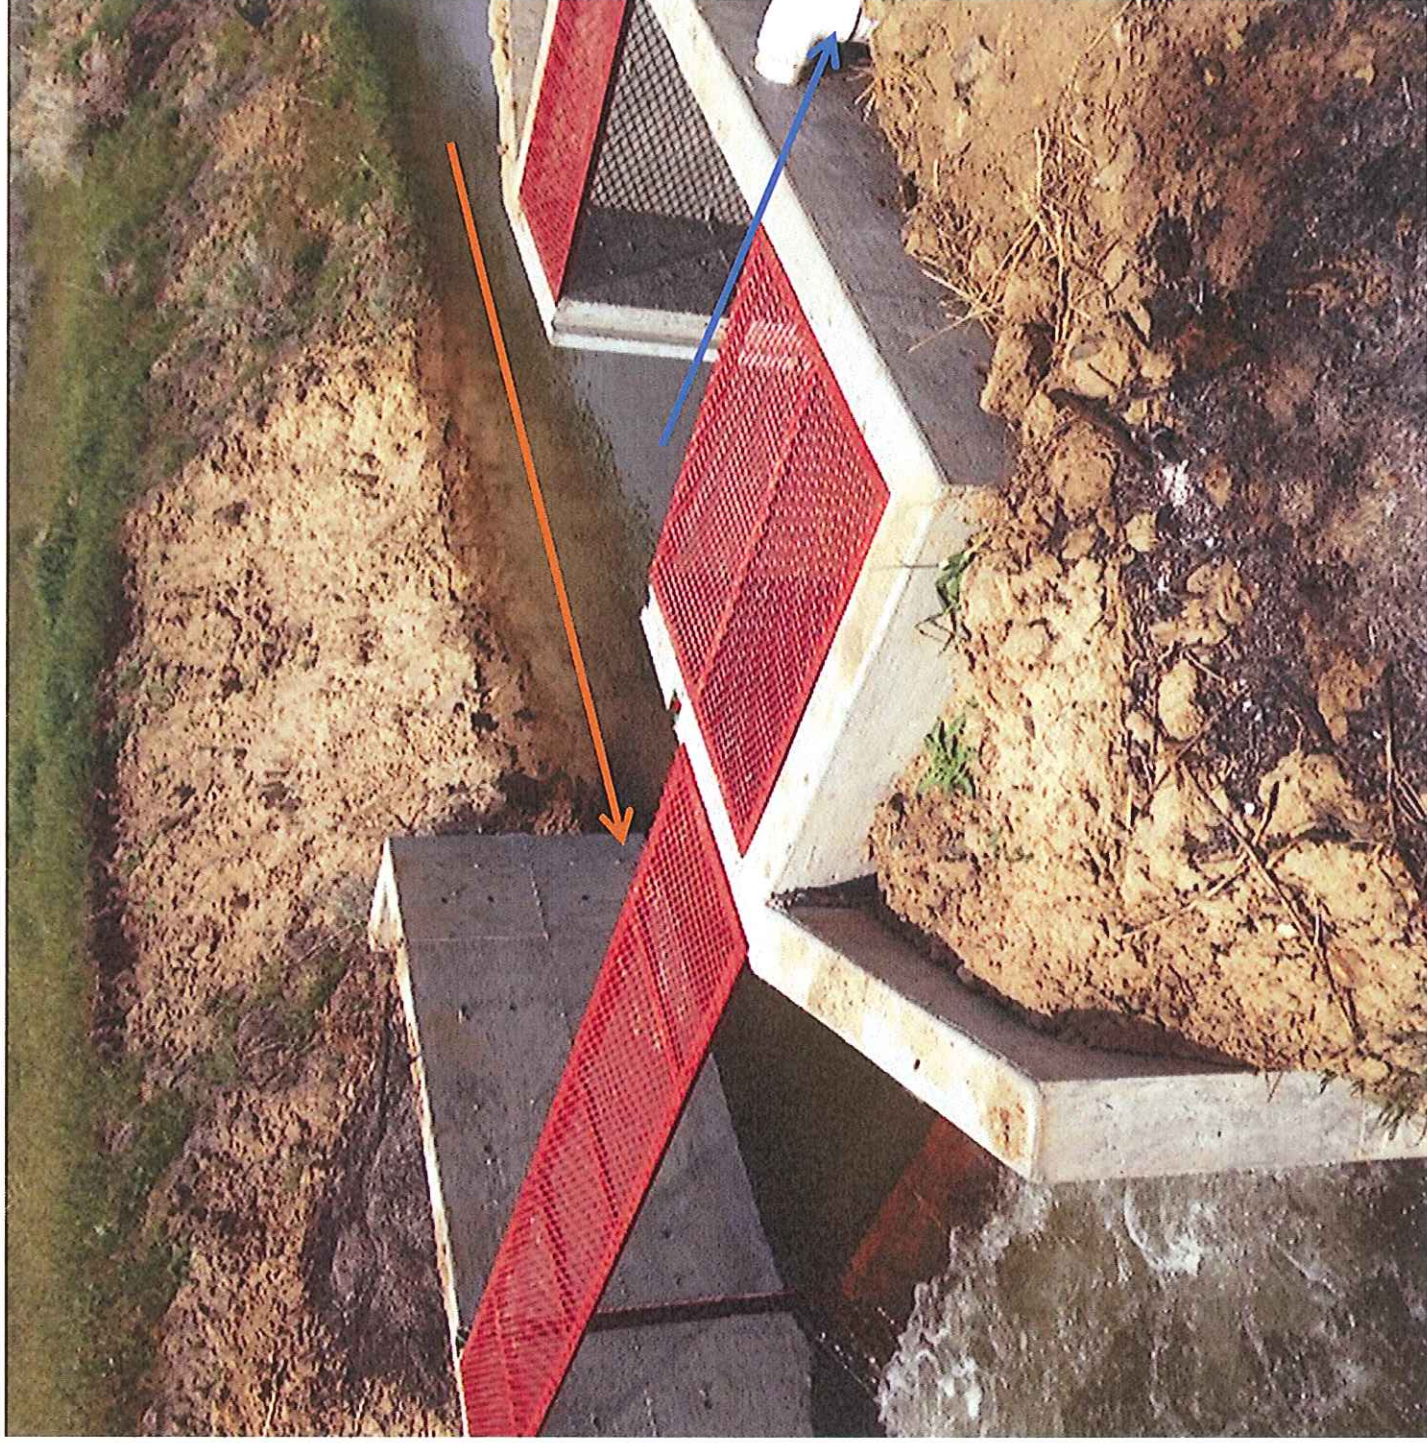
Newly constructed
point of diversion

Orange line is canal
flow.

Blue line is irrigation
(in a
pipe) onto Jones'
property

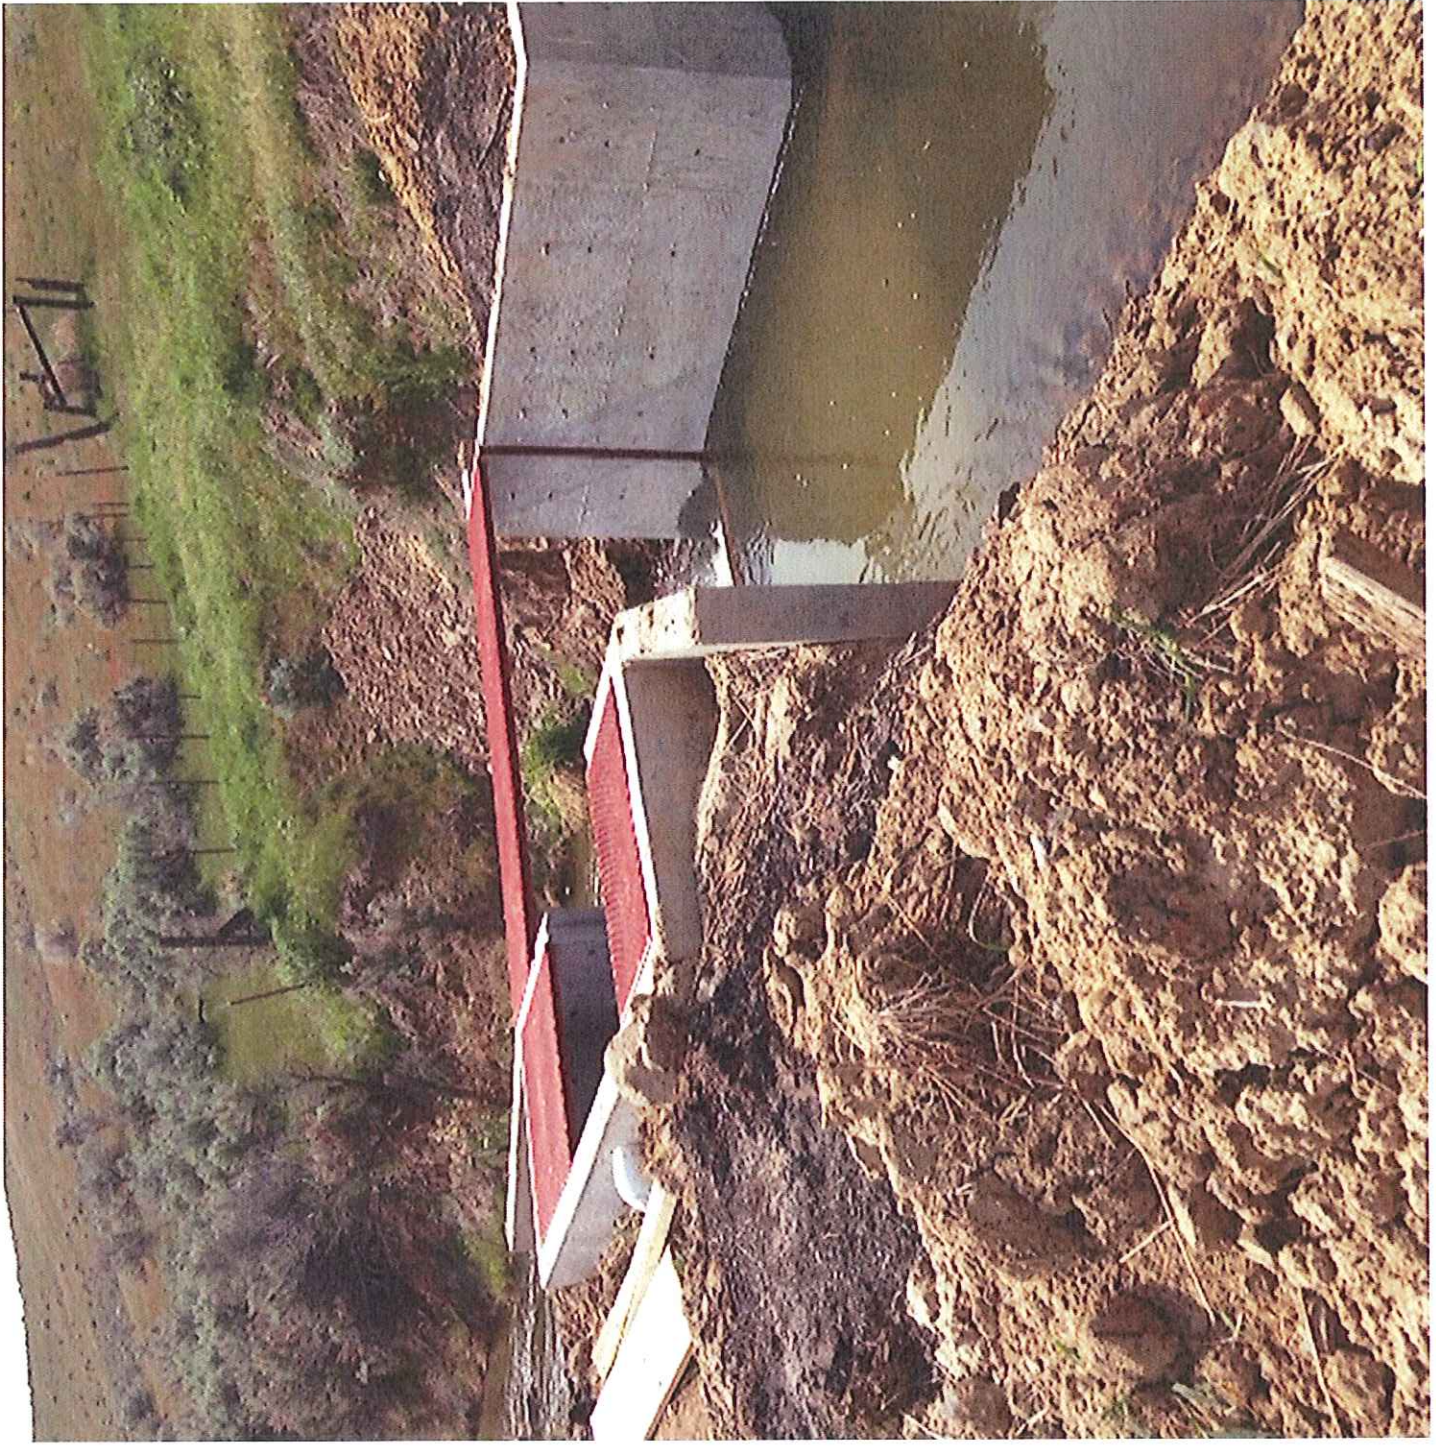
Another view of the
newly constructed
diversion

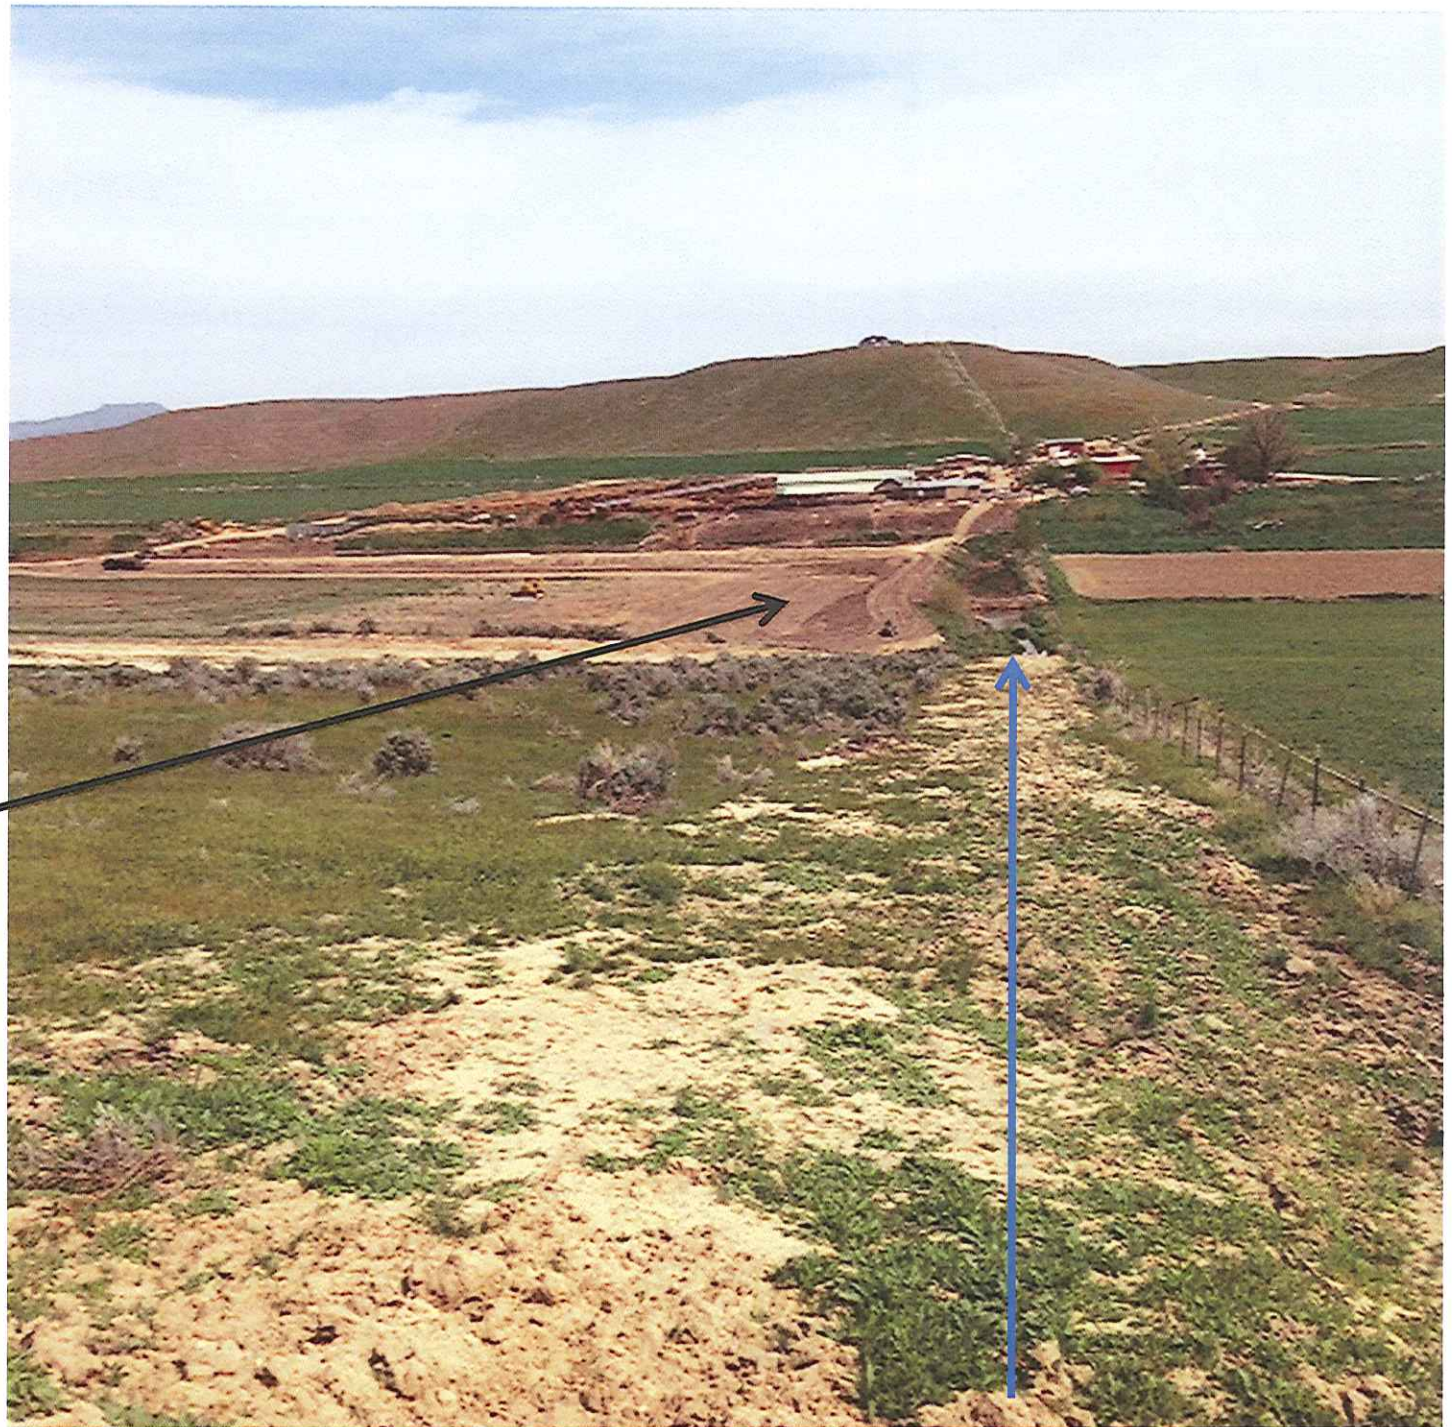
Looking east from
the new point of
diversion

Blue line is water
flow; in new buried
pipe. Irrigation water
exits (see next 2
photos for the
concrete exit
structure)

Shippy's constructed a
new berm for Terry
Jones Sr to help
contain and collect all
field runoff. Per Jones
Sr, NRCS helped with
the sizing of this berm
structure

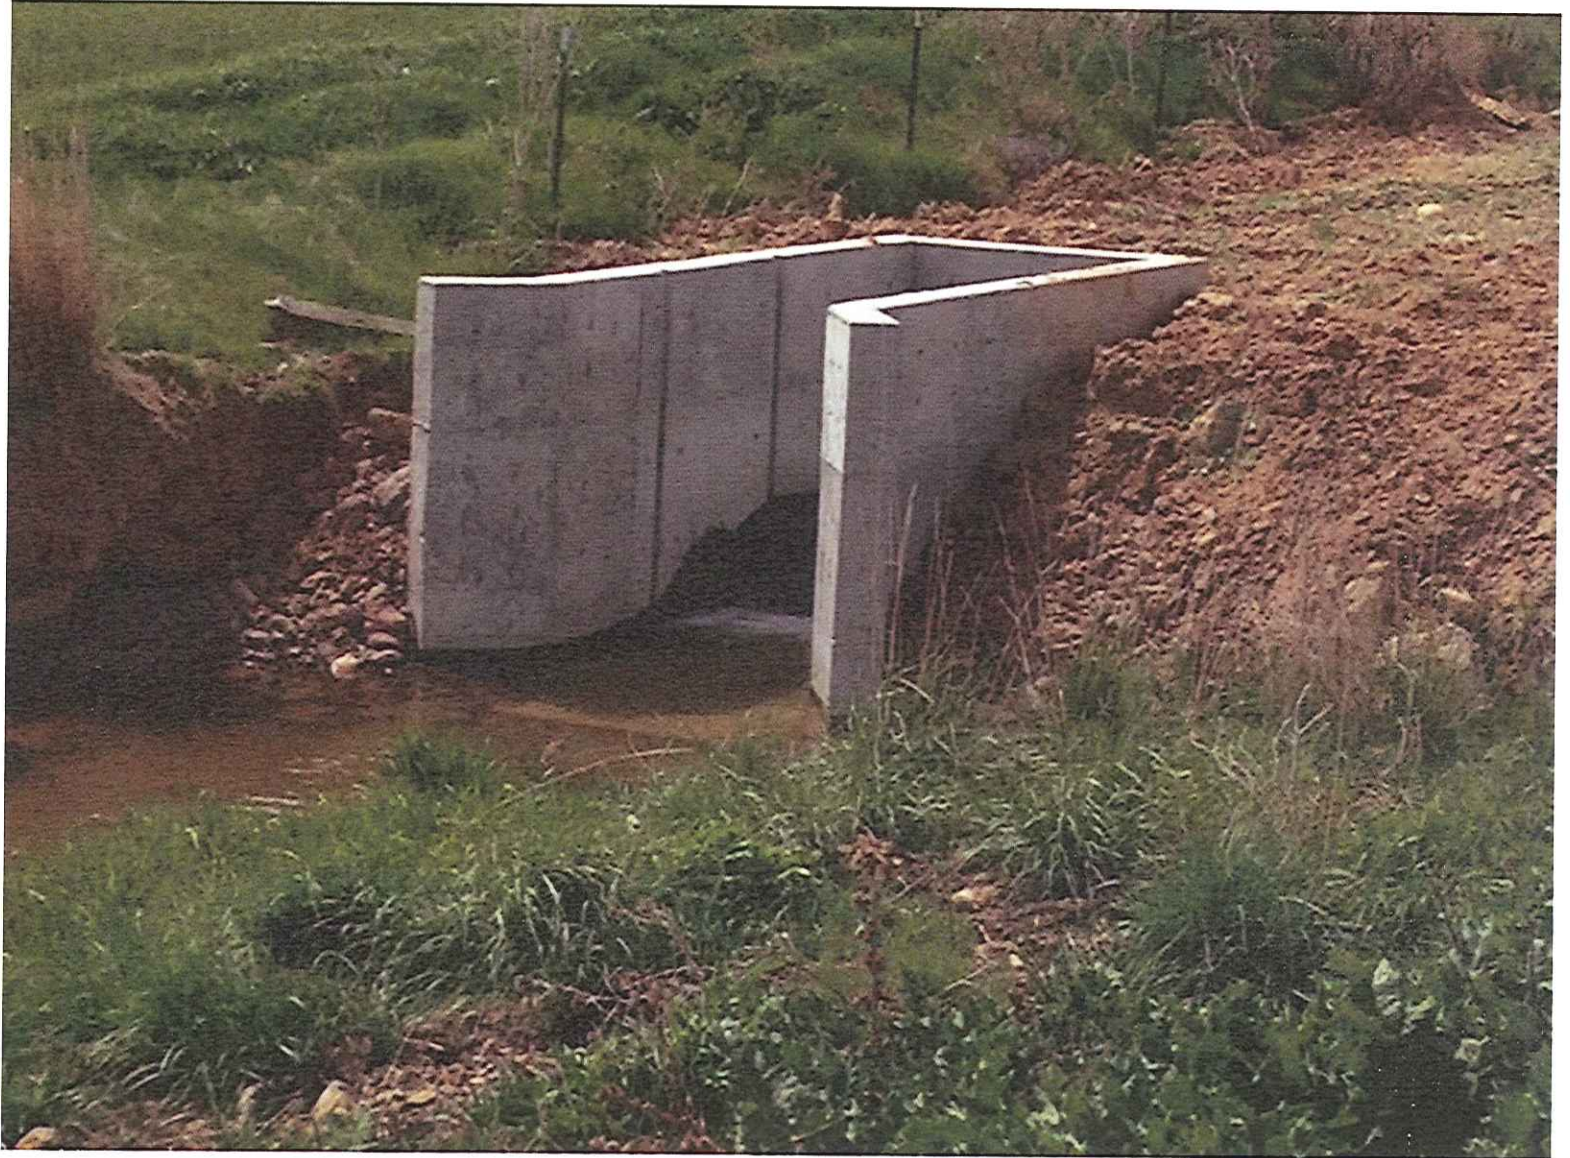
From the point of diversion at the canal, the water is piped, and then exists at this location. New concrete structure to prevent help hydraulic jump scouring.

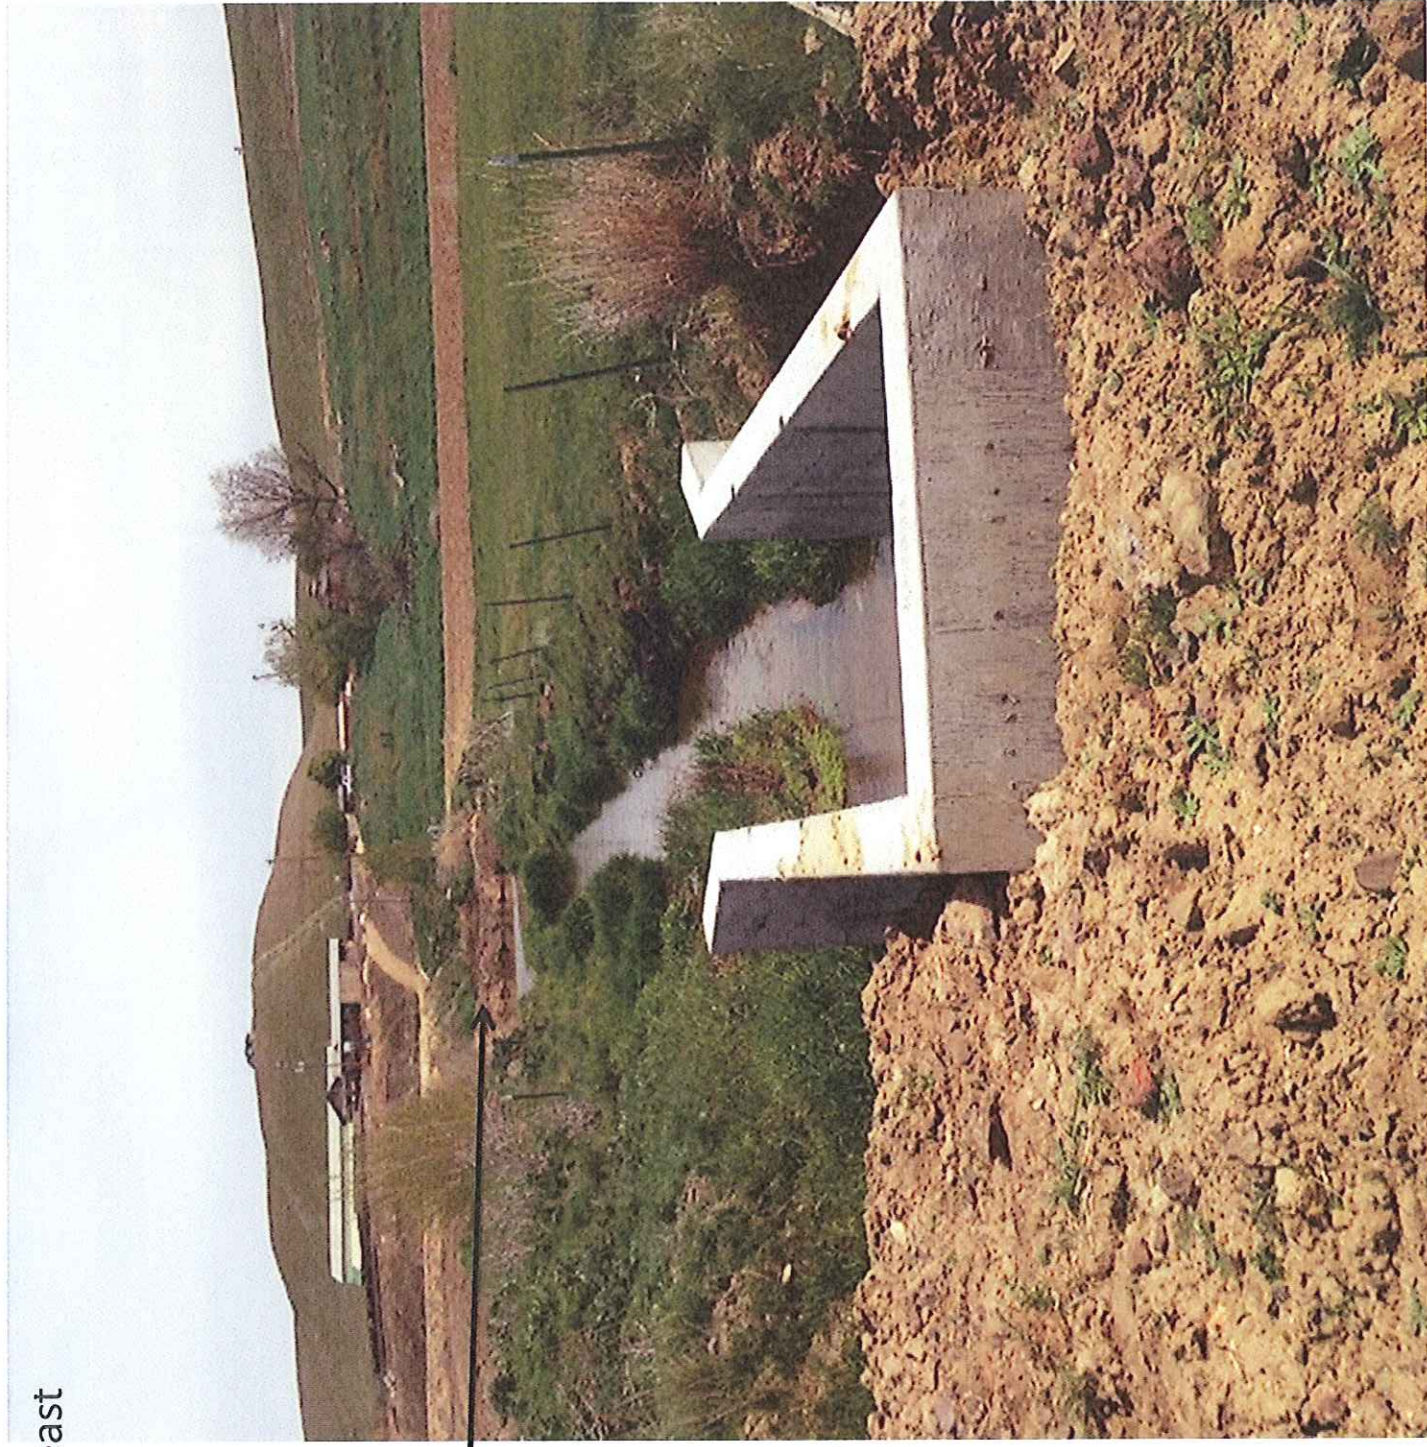
Another view, looking east

Berm that separates
the irrigation tail
water pond and the
irrigation canal water
(see next two pictures)

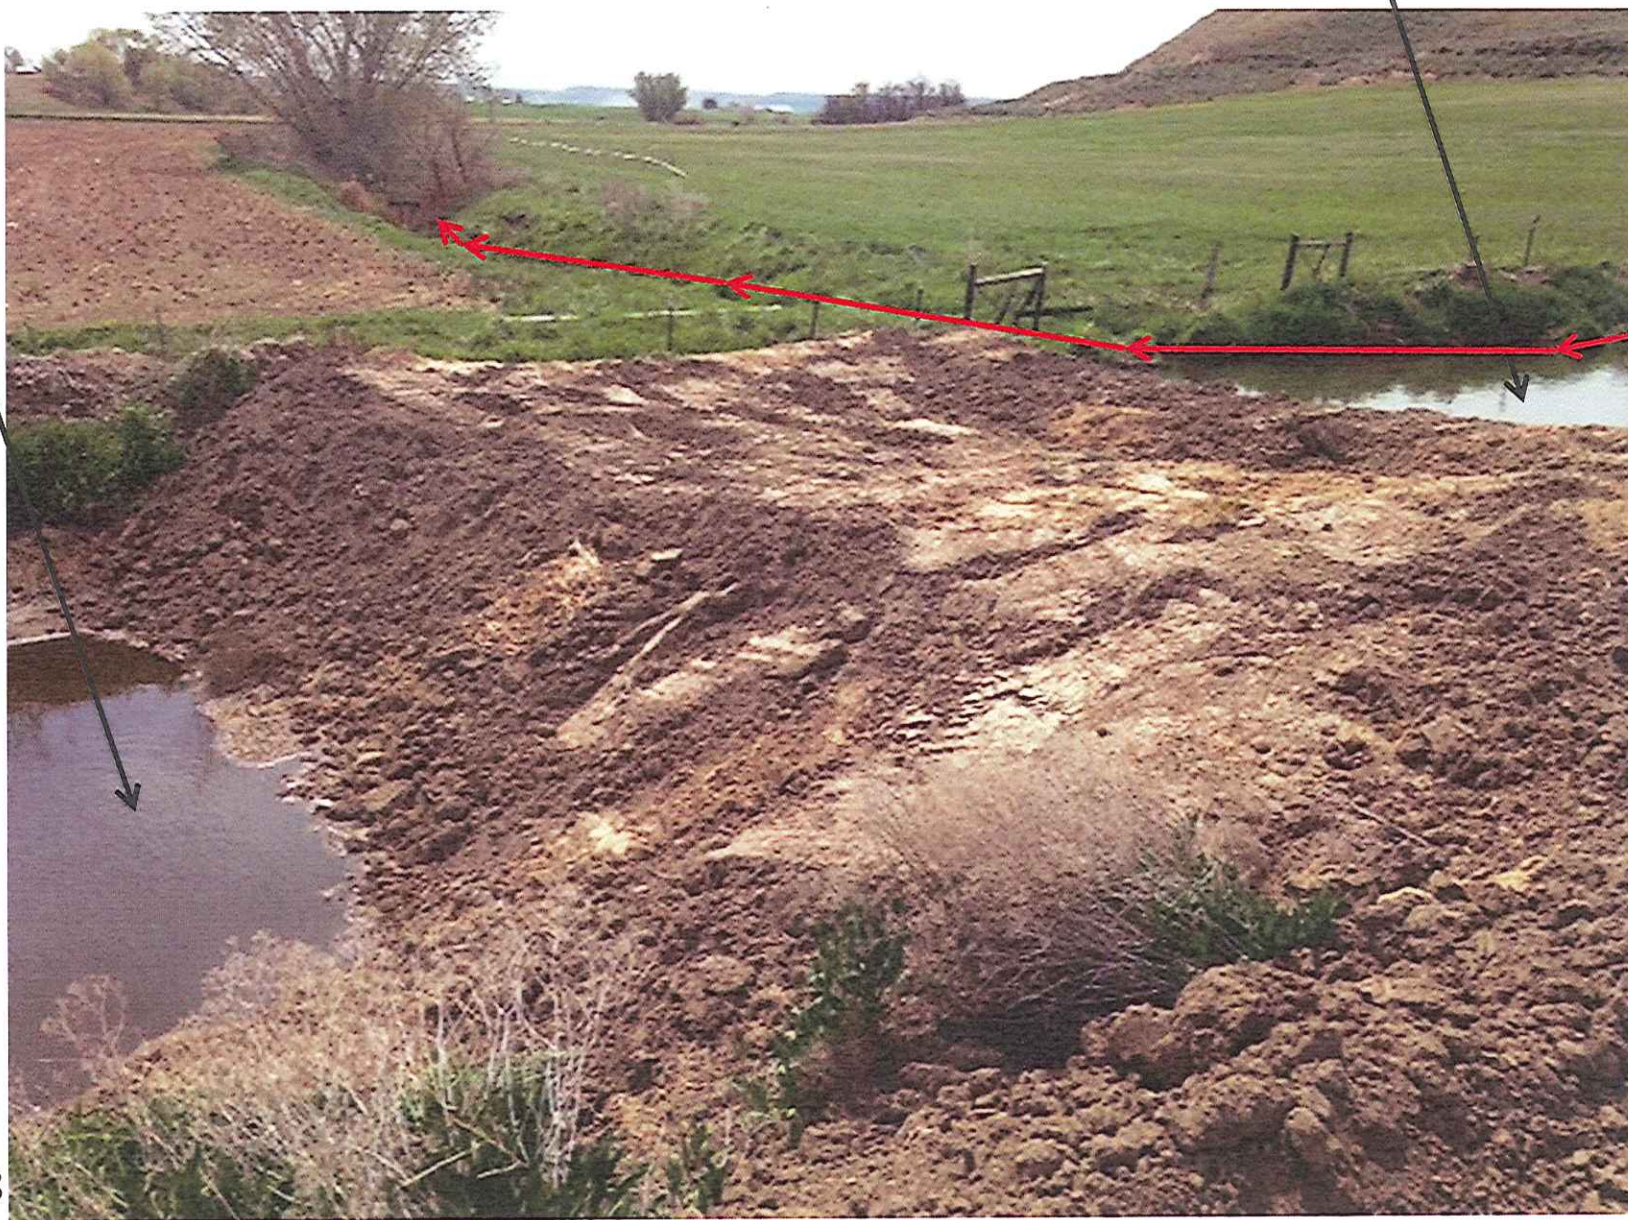
The berm between the irrigation tail water pond and the irrigation water (see pages 11 and 12 of the photos) is approximately 25 feet wide. Mr. Jones also stated that an impermeable liner was placed vertically in the berm to prevent water from the tail water pond leaching into the irrigation water. The top of the newly constructed berm is about 420 feet long and 14 to 18 feet wide. Measurements were taken using a measuring wheel. The north side of the berm slope is approximately a 3 to 1 slope with the south slope varying from a 1:1 to 2:1.

Irrigation Tail Water Pond; tail water that is in the pond is from recent land application to triticale per Terry Jones, Sr.

Irrigation water from the canal
(red line shows flow direction)
